# Restoring Confidence in Gas Lift Operations:

## How Panametrics' Clamp-On Flowmeters Uncovered Hidden Discrepancies

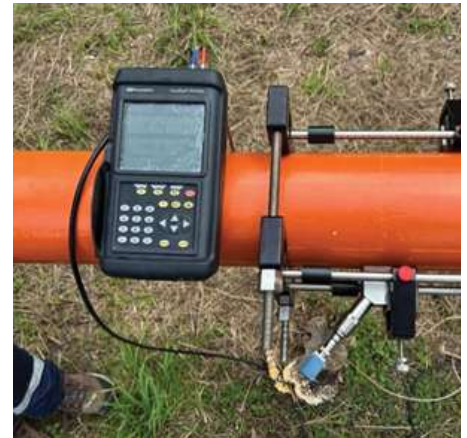
**Fig. 2:** PT878GC installed on the main 6" CS line

The Panametrics team deployed the PT878GC portable clamp-on gas meter to each individual line, collecting flow data for approximately 15 minutes per line. Pressure and temperature readings were manually entered using local instrumentation. Throughout the process, diagnostic checks were closely monitored, and the results were excellent—particularly with the triple traverse setup, which further enhanced measurement reliability. This approach provided a high level of confidence in the accuracy of the recorded flow rates.
