## Application note

# Steel production plant

TransPort PT878GC portable gas clamp-on tracks oxygen main feed line flow to the steel plant from the oxygen production facility

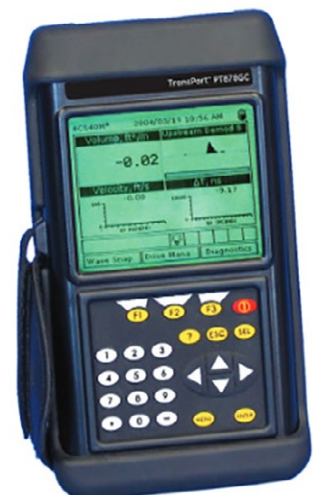
| Pipe material | Carbon steel, diameter: 8 in (200 mm), thickness: schedule 40 (7.11 mm) |
| Medium | Oxygen |
| Pressure | 9 to 12 barg (130 to 174 psig) |
| Temperature | 25 to 35°C (77 to 95°F) |
| Velocity | 0 to 18 m/s (0 to 59 ft/s) |

With plenty of available straight runs and enough pressure, the PT878GC setup was quick and easy, and the comparison started. Under normal flow conditions, both meters were very nicely tracking with less than 1% difference. But when the process was changing, the vortex meter had erratic readings while our PT878GC kept stable as the customer expected. Enotek suggested that the customer check the vortex grounding and that solved the issue. We now have a happy customer.

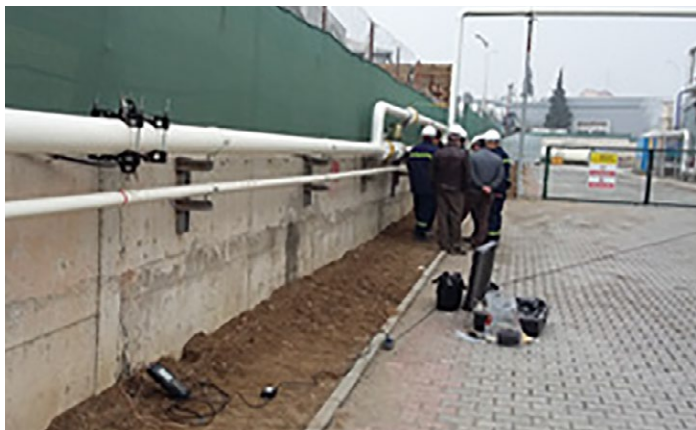
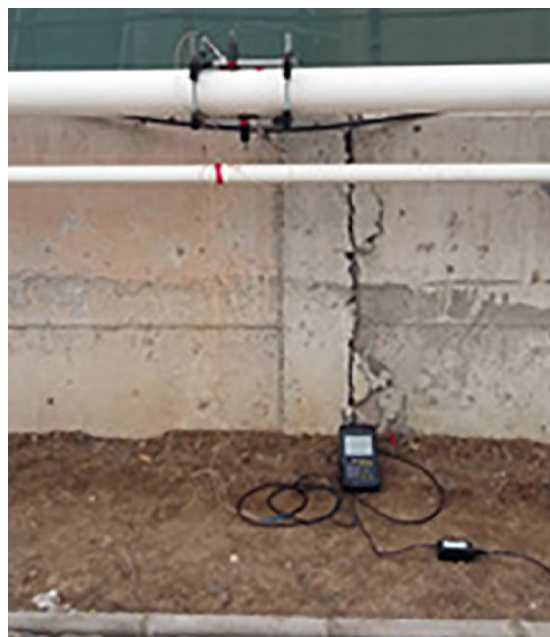
C-RS 401 transducer installation on the penstock
