# Flow measurement for natural gas distribution

Digital Flow CTF878 clamp-on ultrasonic flow meter with C-RL transducers installed on various pipe using a CFT clamping fixture. See each location for transducer details.

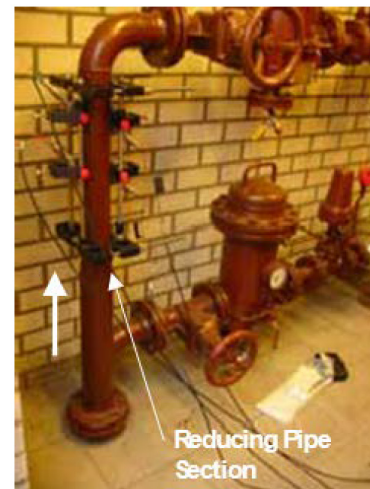
C-RL transducers installed on a 3 in (80 mm) pipe in a reducing station

#### Location 1: Reducing station

The equipment was installed in a reducing station on a carbon steel pipe upstream of a reducing valve with pressure ranging from 116 to 14 psig (9 to 2 bar).

Flow profile was good despite the disturbances upstream. The noise from the reducing valve was not present in this location. Good flow profile was attributed to the 3 to 4 in (80 to 100 mm) reducing pipe section.

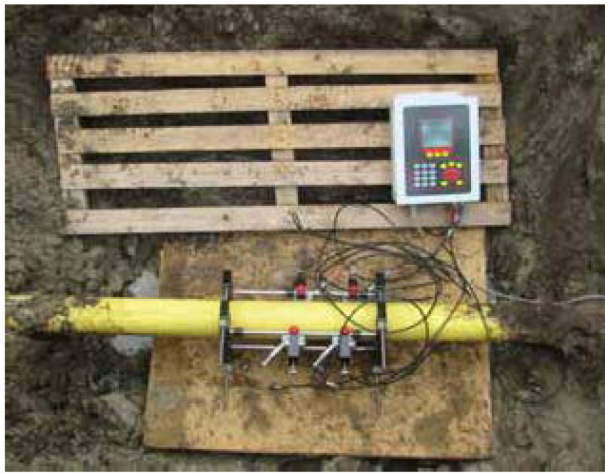
C-RL transducers installed on a 4 in (100 mm) carbon steel pipe with a 0.08 in (2mm) PE coating (outside)

## Location 2: Underground carbon steel pipe with polyethylene (PE) coating

Flow readings and diagnostics at this location were excellent. Typically, polyethylene (PE) has interfered with integrity of the transducer signal; however, it did not present a problem here. It is assumed the PE coating had no effect on the quality of the transducer signal.

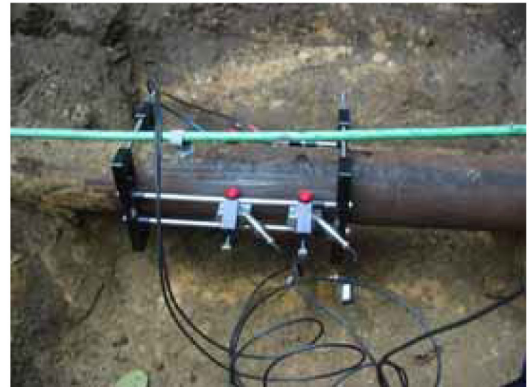
C-RL transducers installed on a 6 in (150 mm) cast iron pipe

Despite the poor pipe wall conditions, flow readings and diagnostics were excellent at this location as well.

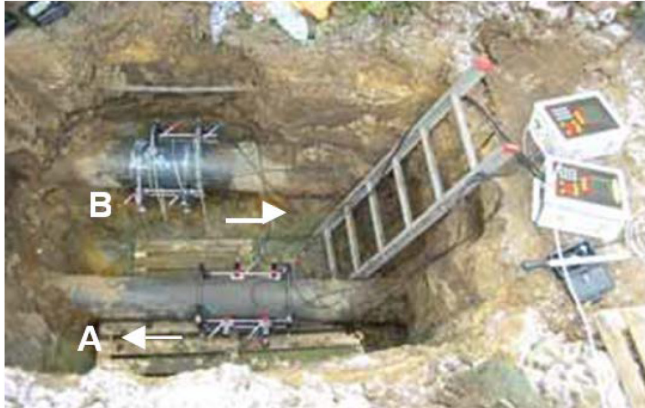
C-RL-304 (A) and 306 (B) transducers installed on pipe leading to and from the reducing station

Transducers were installed on two cast iron pipes approximately 33 ft (10 m) away from the reducing station. Measurements were good despite the valve noise present. DMP-1 was applied to location B.

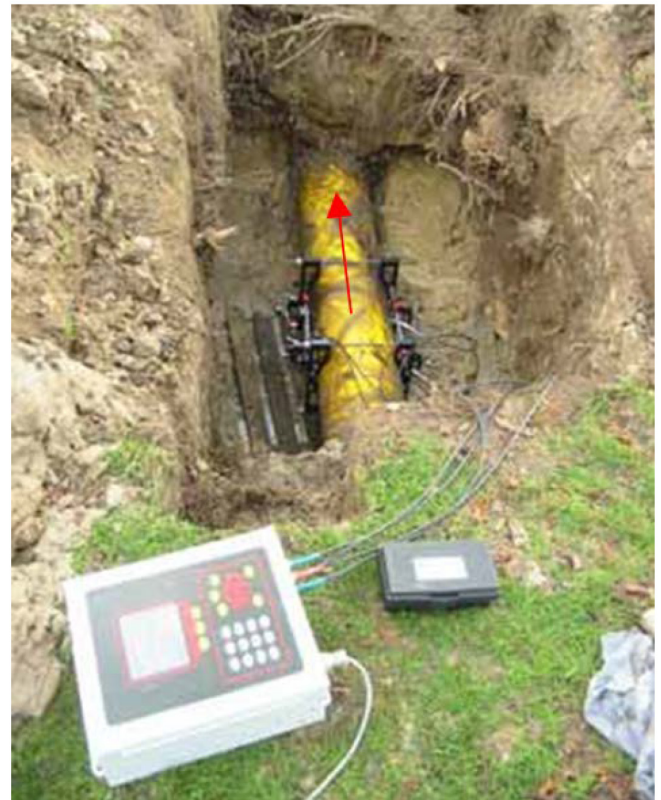
C-RL-304 Transducers installed on a 12 in. (300 mm) PVC pipe downstream of reducing station

Flow measurements were good at this location despite valve noise. Minimum velocity was approximately 3 to 5 ft/s (1 to 1.5 m/s) with good straight run.

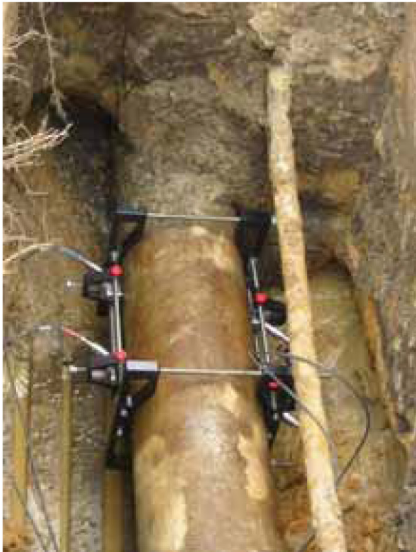
C-RL-304 transducers installed on a 12 in (300 mm) asbestos cement pipe downstream of reducing station

This measurement location was initially thought to be a bad location for two reasons. First, the pipe was very old and secondly, it had a 0.94 in (24 mm) wall thickness of pure asbestos cement.

Despite the pipe condition, the C-RL-304 transducers were installed and the CTF878 returned good flow readings.
