## Measuring brine

Mag broken, clamp-on measurement within 15 minutes

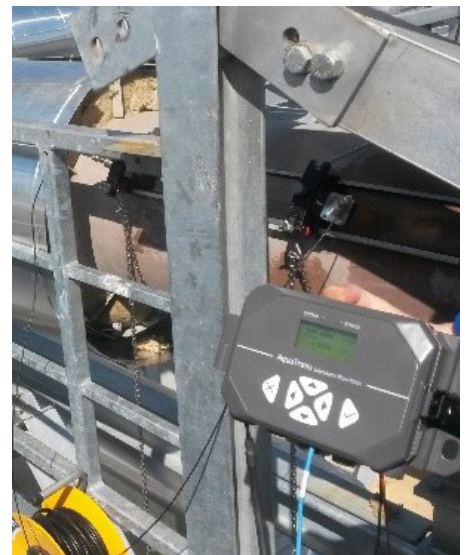
The electromagnetic meters are used to monitor the well and to trigger the needed amount of corrosion inhibitors to inject into the wells. A small stripe of brown water was dripping from the interconnection of the electromagnetic body and the electronics reading. For sure, the insulation had not survived this challenging application. The meter's lining had come loose due to temperature and pressure changes.

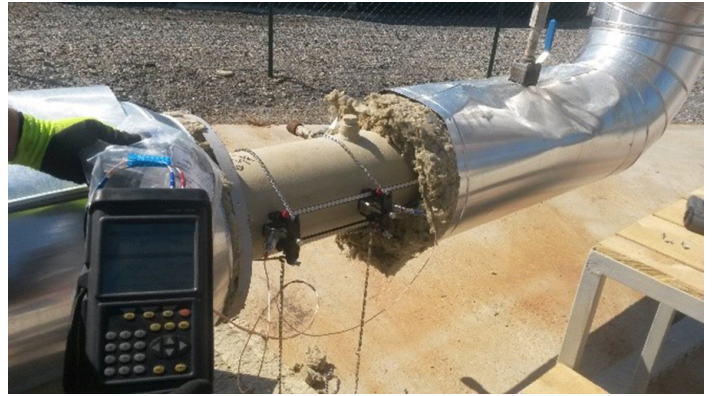
Our Transport PT878 with high-temperature C-PT transducers were used for testing purposes. Given previous experience, the confidence level was high. Within 15 minutes, our PT878 with C-PT had stable signal and good diagnostics. A few days later, the customer decided to permanently install four AT600s.
